**Oakland Fire Department**  
**Origin and Cause Report**  
**Incident # 2016-085231**  
**December 2, 2016**  
**1315 31<sup>st</sup> Avenue**

March 18, 2017 edited May 11 2017

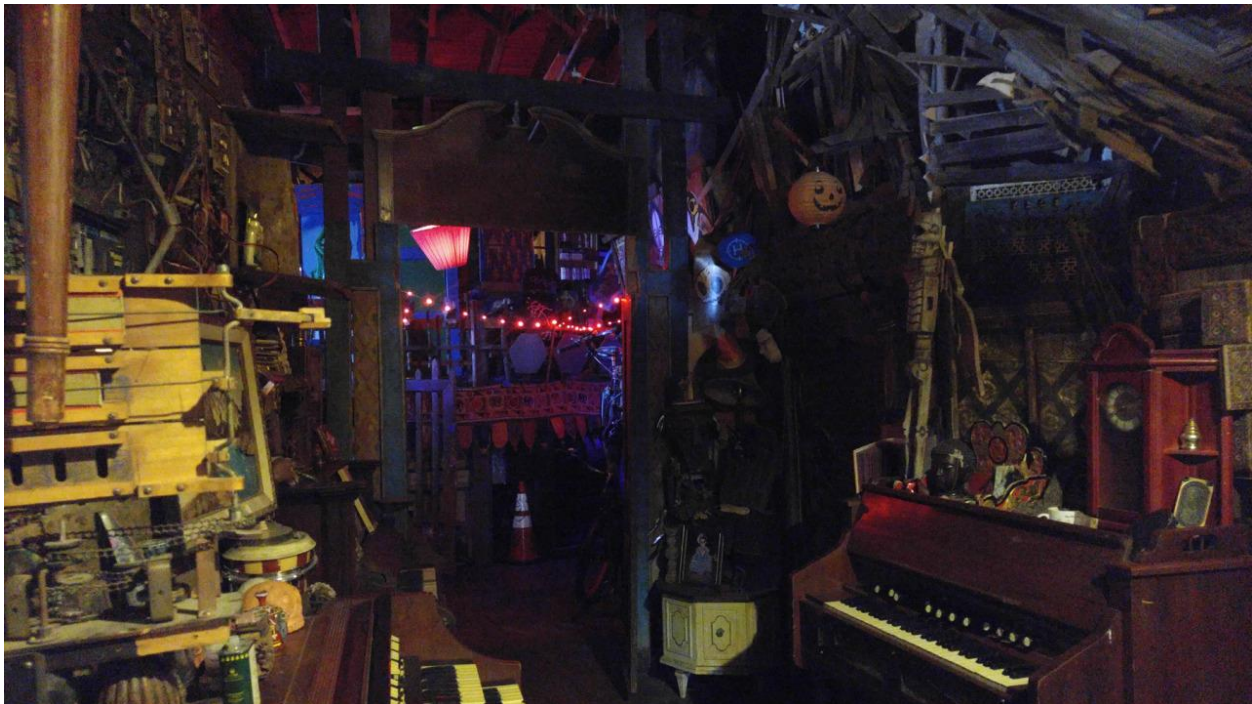
The main entrance to the ground floor was through the man-door on 31<sup>st</sup> Avenue. From there, makeshift hallways led erratically deeper into the building. The hallways were not constructed of traditional materials such as drywall-covered, wood-framed walls. Instead, the walls of the hallways were assembled together from aggregates of salvaged and scavenged materials, such as pianos, organs, windows, wood benches, lumber, and innumerable other items stacked next to and on top of each other. (see photo below)

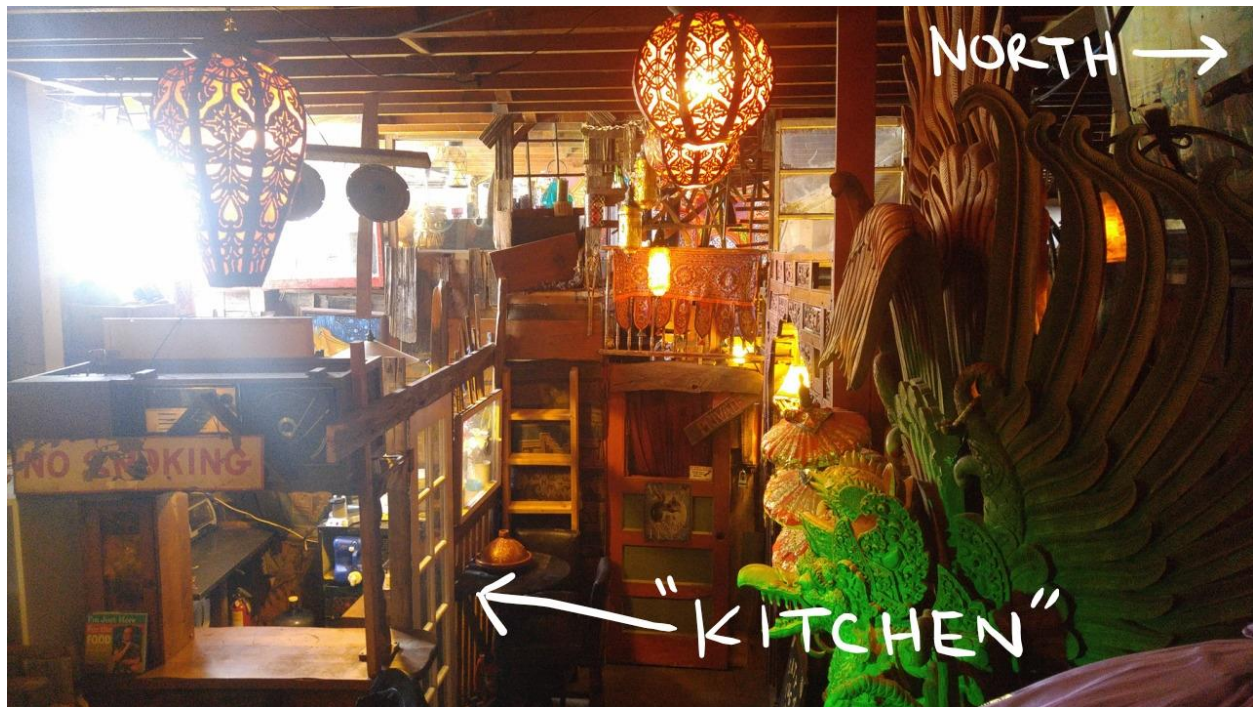
Inside the front door to the west was an area the residents referred to as “the kitchen.” West of the kitchen, in the southwest corner of the building, four people had live-work spaces. (see photo below)

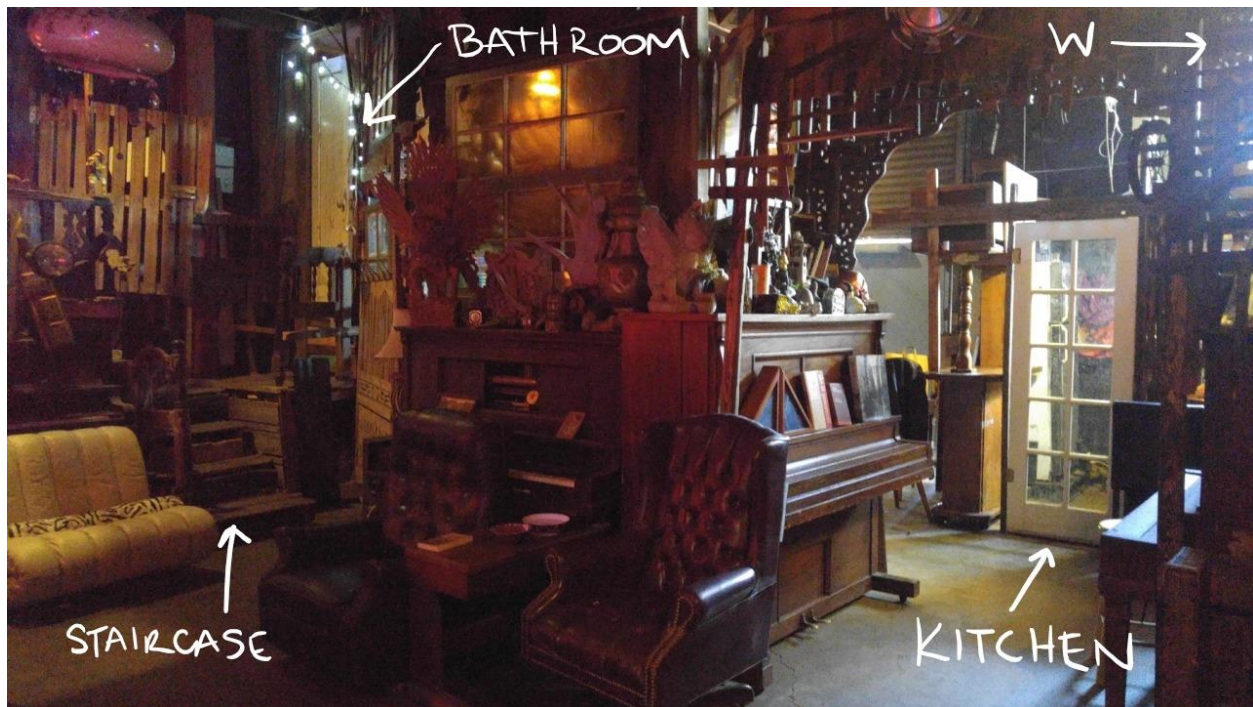
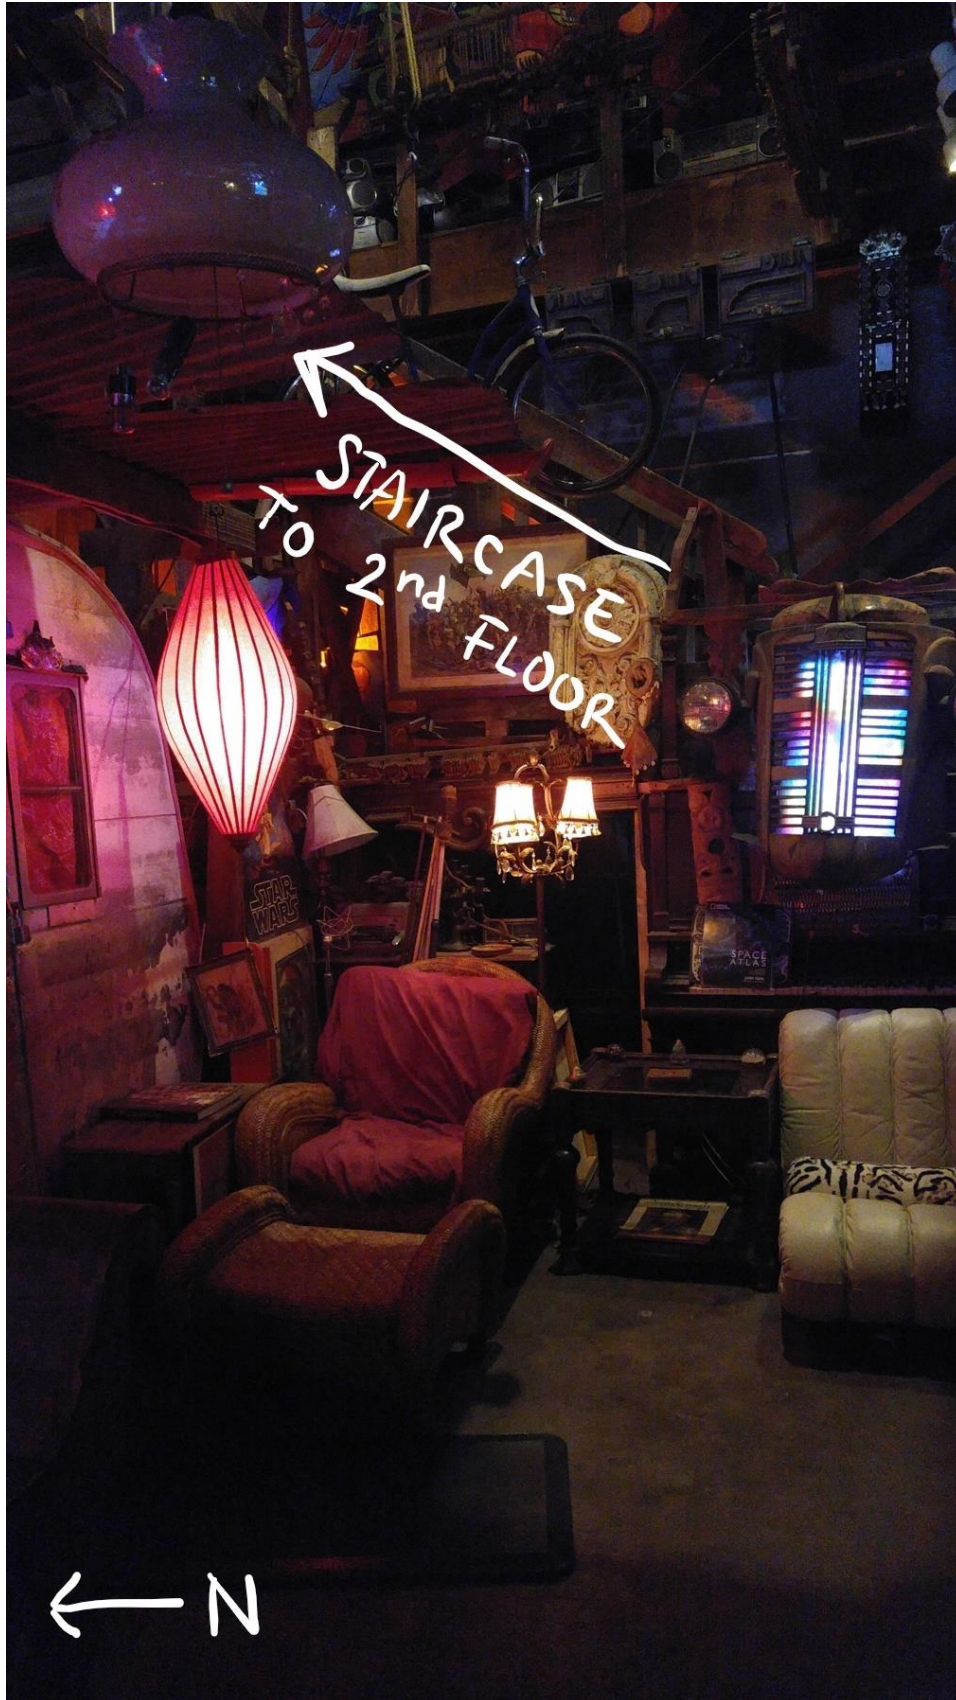
The front staircase was located along the east wall at the front of the structure. It was constructed of various wooden planks and wooden studs, as well as portions of wooden pallets at its top where it accessed the second floor. One of two bathrooms was elevated slightly off ground level where the lower staircase landing was located. The orientation of the staircase was such that it first led eastward where it bordered the east wall, then turned north (rearward), where it then turned slightly west at the very top of the staircase at the second floor.

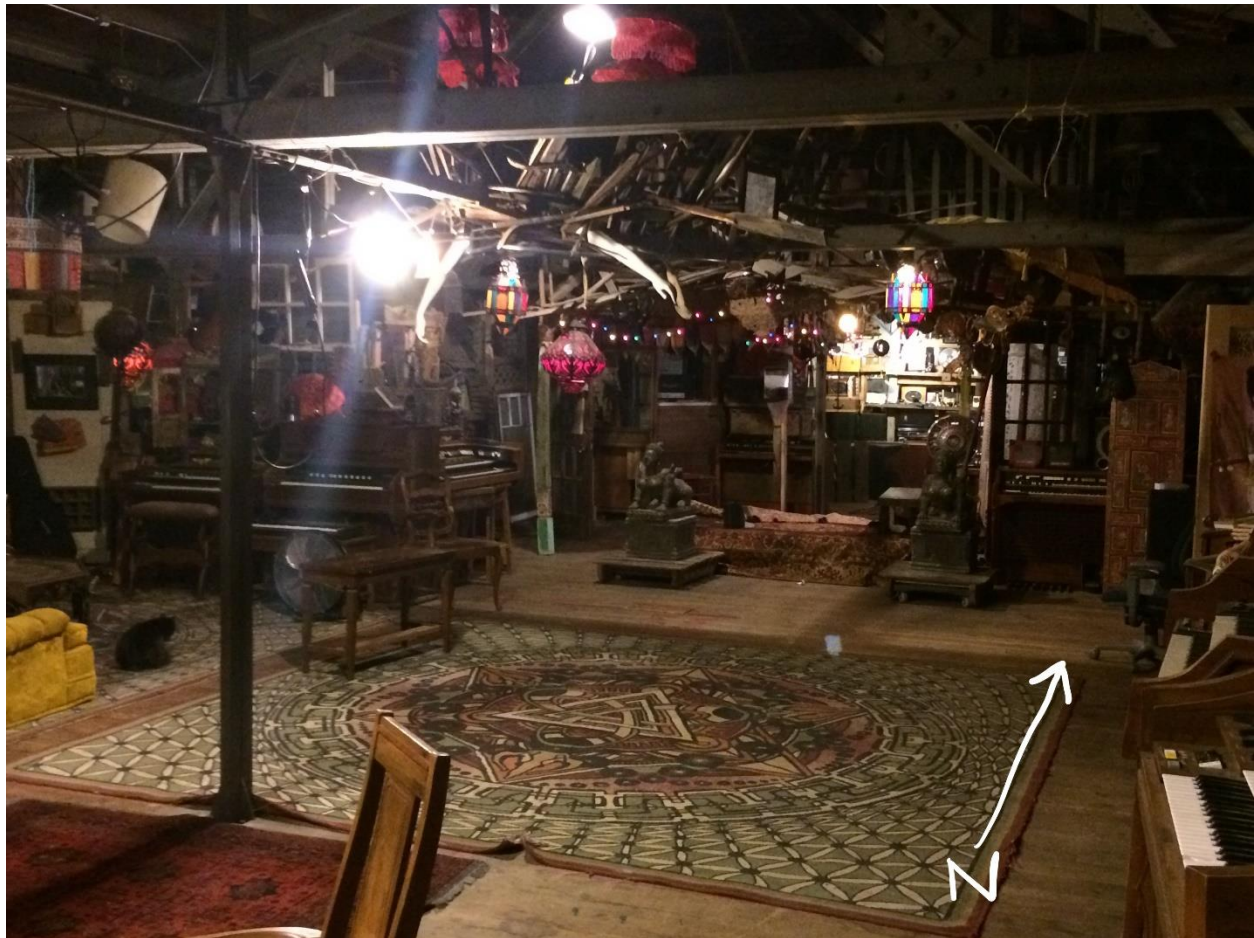
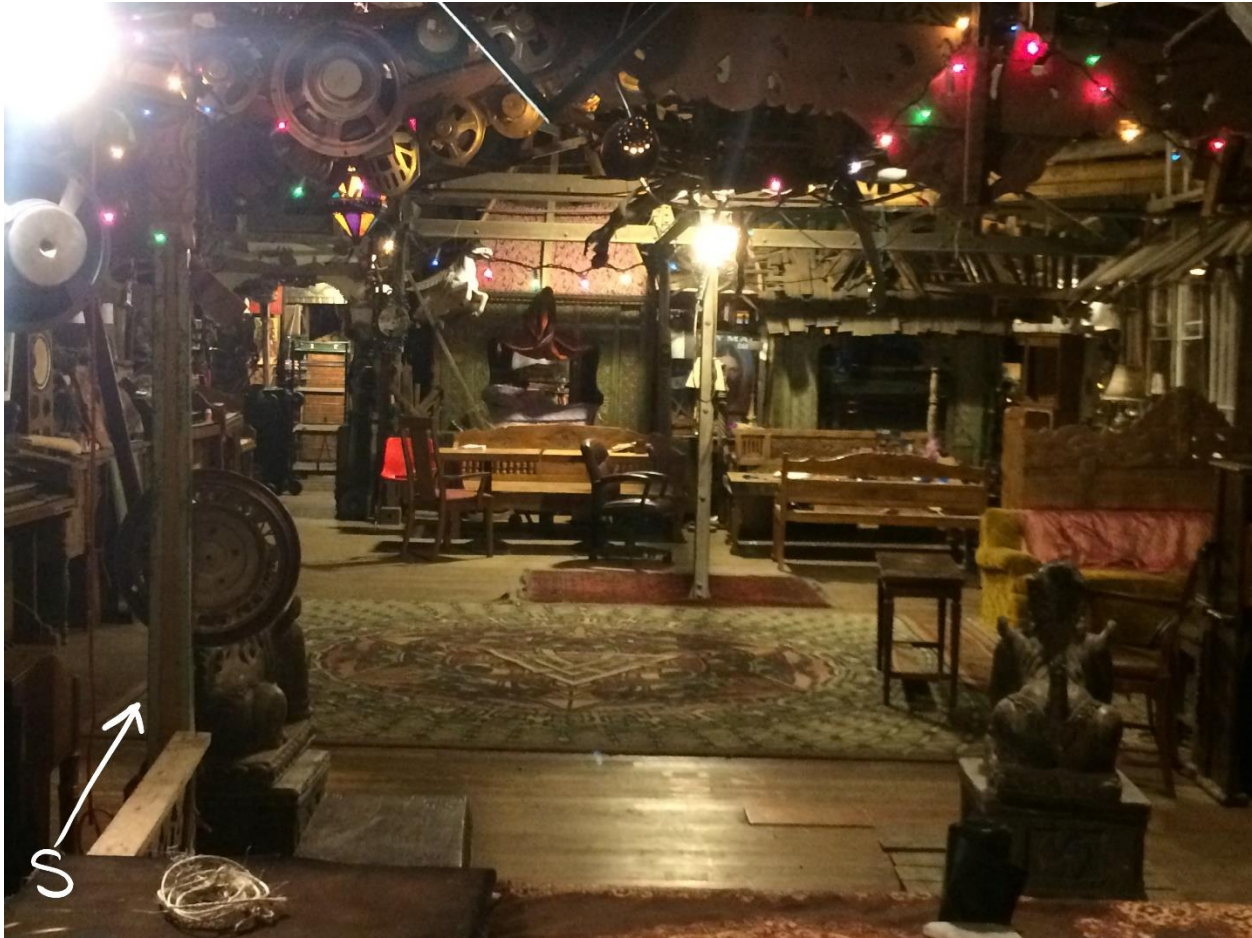
The second story contained fewer living spaces and hallways, and an open area for events was the predominant feature. A family lived in a space at the south end and two other tenants were reported to have living spaces on the second floor; one along the east wall and one in the northwest corner. Most of the space was open with areas of couches and chairs for people to socialize. There was an area at the north end of the second floor where musicians or disc jockeys set up when events took place. (See photos below)

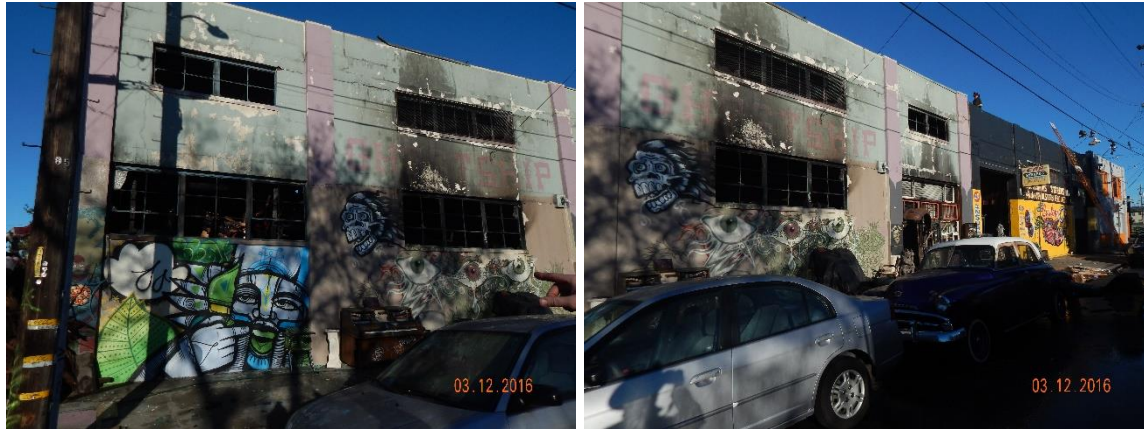
The front of the structure faced 31<sup>st</sup> Avenue. The exterior wall of 1315 31<sup>st</sup> Avenue was partitioned into 3 vertical sections, running from top to bottom. Windows were present in each section, on the first and second floors, with the exception of the east section that contained a metal roll-up door, with windows above. The roll-up door contained a man-door. No intact glass was present on either level. There was smoke staining above the windows in the middle section on the first and second floors as well as above the roll-up door. There was minimal smoke

staining above the windows in the east section on the second floor. Minor smoke staining was noted above the windows in the west section of the wall. (See photos below for the layout and location of the openings in the south wall of the structure.)

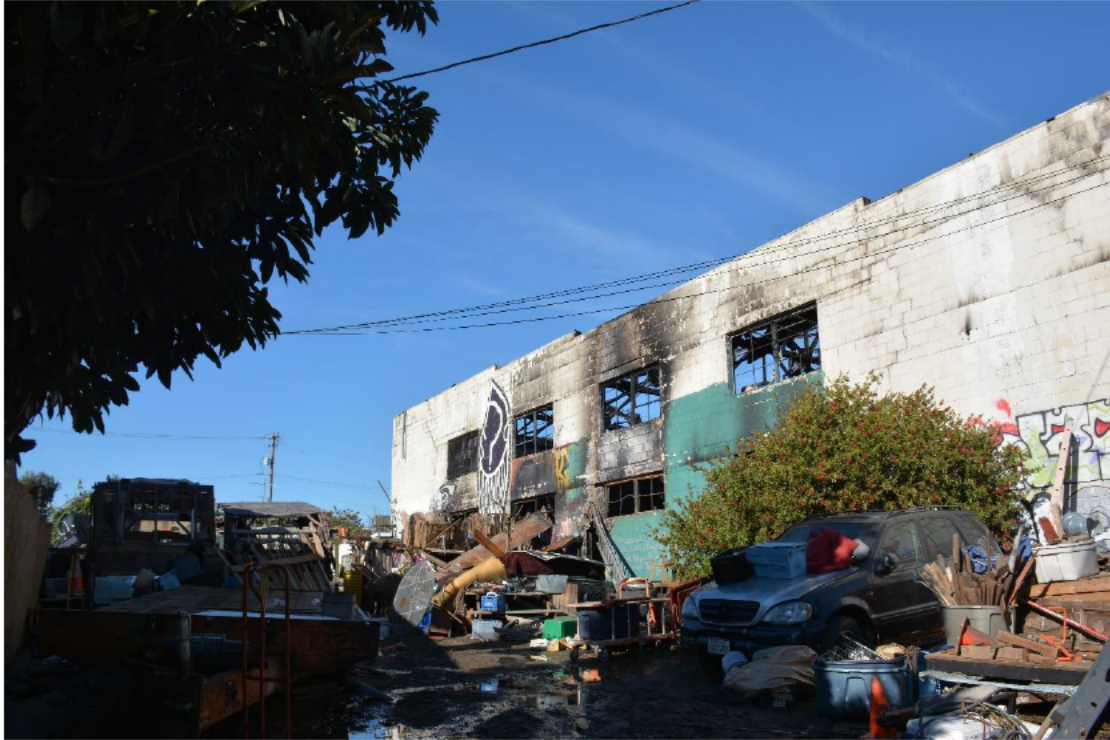
The B-side of the building bordered an open lot containing a large amount of discarded items. A non-permanent structure used as living quarters and fashioned out of various materials was located toward the north (see photo below). Windows were present on the B-side on the first and second levels, along the rear (north) two-thirds of the building. The only window with any glass remaining was the first floor southernmost window. The second floor rear-most (north) window contained metal mesh over the window opening. In the right-most (south) first and second floor windows, the upper pane was in an open position, swung outward from the top hinge.

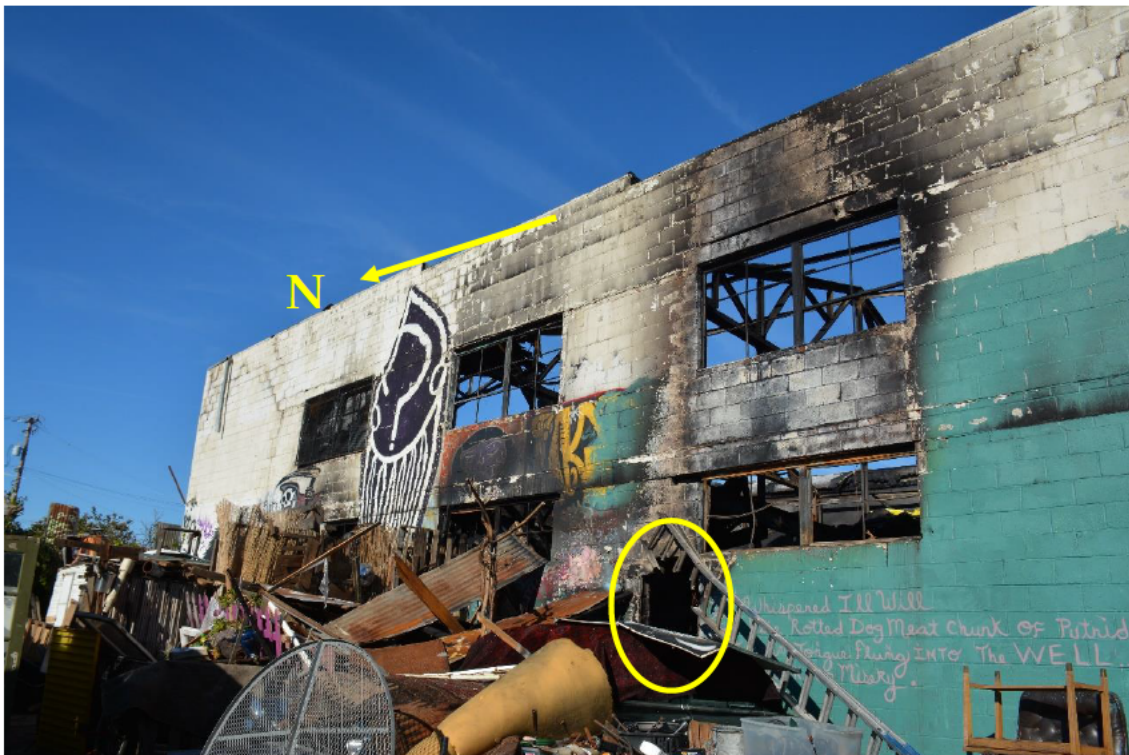
A single door-opening (created by removing concrete blocks from the wall) was present along the ground floor, at approximately the midway point (see below-circled). Fire and smoke damage was heaviest above the middle windows on the 1<sup>st</sup> and 2<sup>nd</sup> floors. (see photo below)

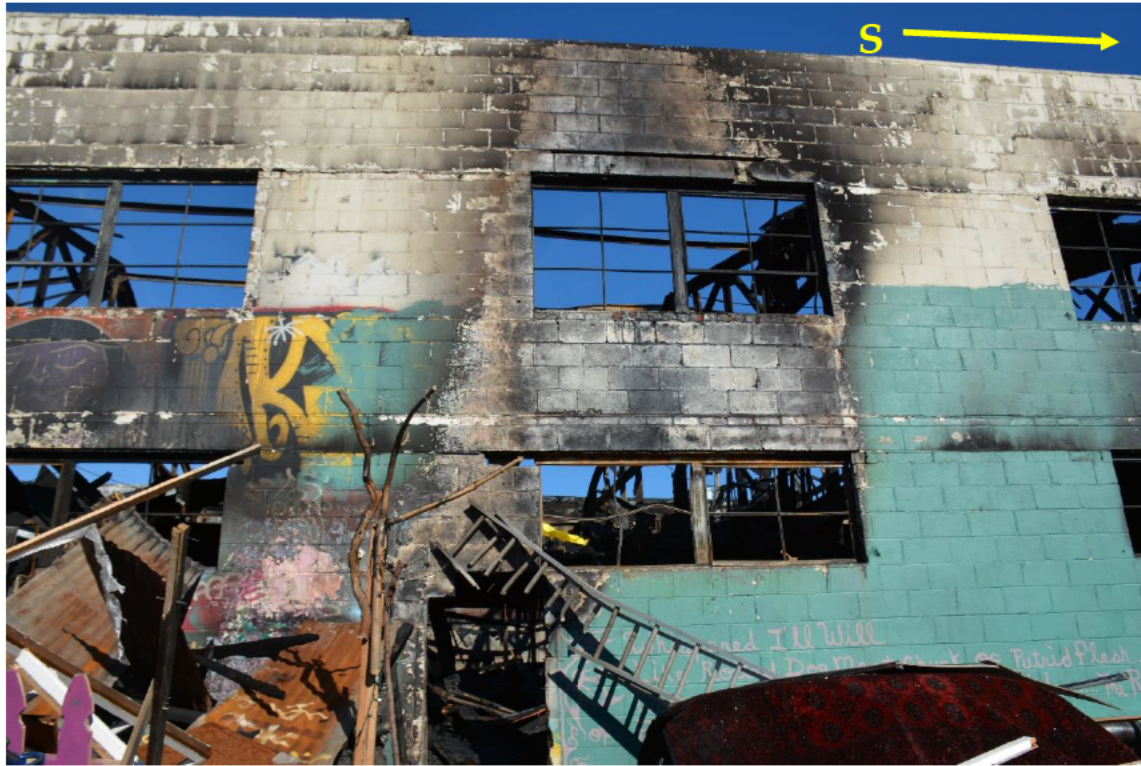
Additionally, the fire pattern above the single man-door intersected with fire patterns around the windows above and slightly to the right of the doorway.  
(see photo below)

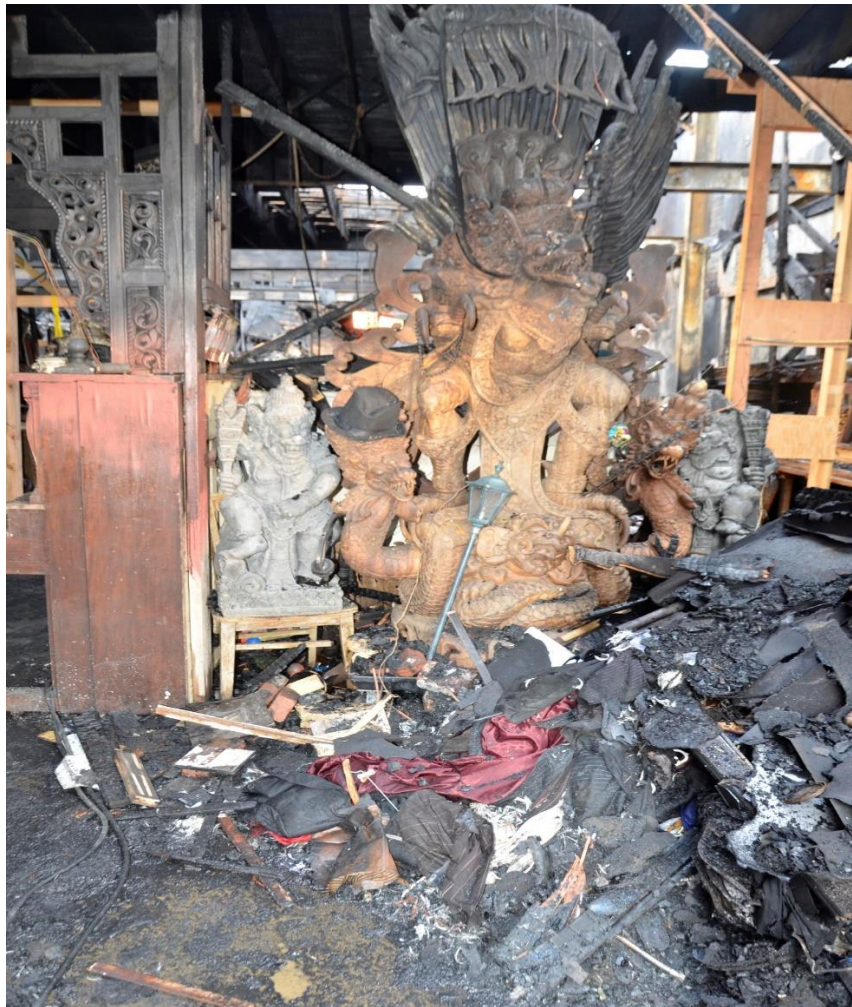
On December 3, 2016, entry was made into the 31<sup>st</sup> Avenue door opening. Directly inside was a large wooden bird-like statue (see photo below.) The statue was intact but sustained heat damage at its top. This statue created an impedance to movement and directed entering occupants to the left. To the left (west) was the room the tenants describe as the kitchen area. This room sustained some heat, soot and water damage but was in relatively good condition. To the west of the kitchen were living spaces.

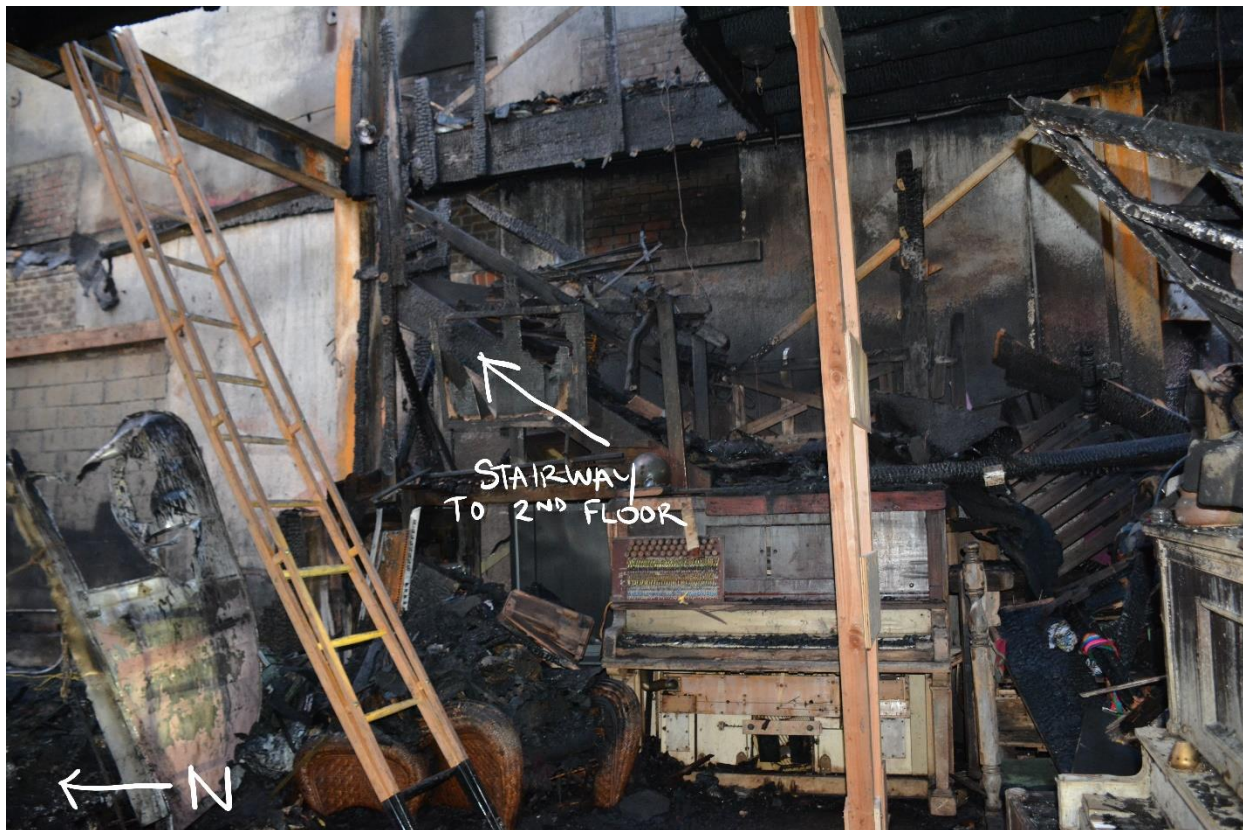
To the north of the door opening, left of the statue, was a passageway lined with pianos and other items. These items exhibited some heat damage to upper portions of the contents but the lower level items (pianos, wooden benches, chairs) were intact. To the east was location of the front (south) staircase to the second floor. The bottom steps to the mid -section of the staircase were intact. The upper section of the staircase and the second floor surrounding the staircase had collapsed onto the first floor. (see photo below)

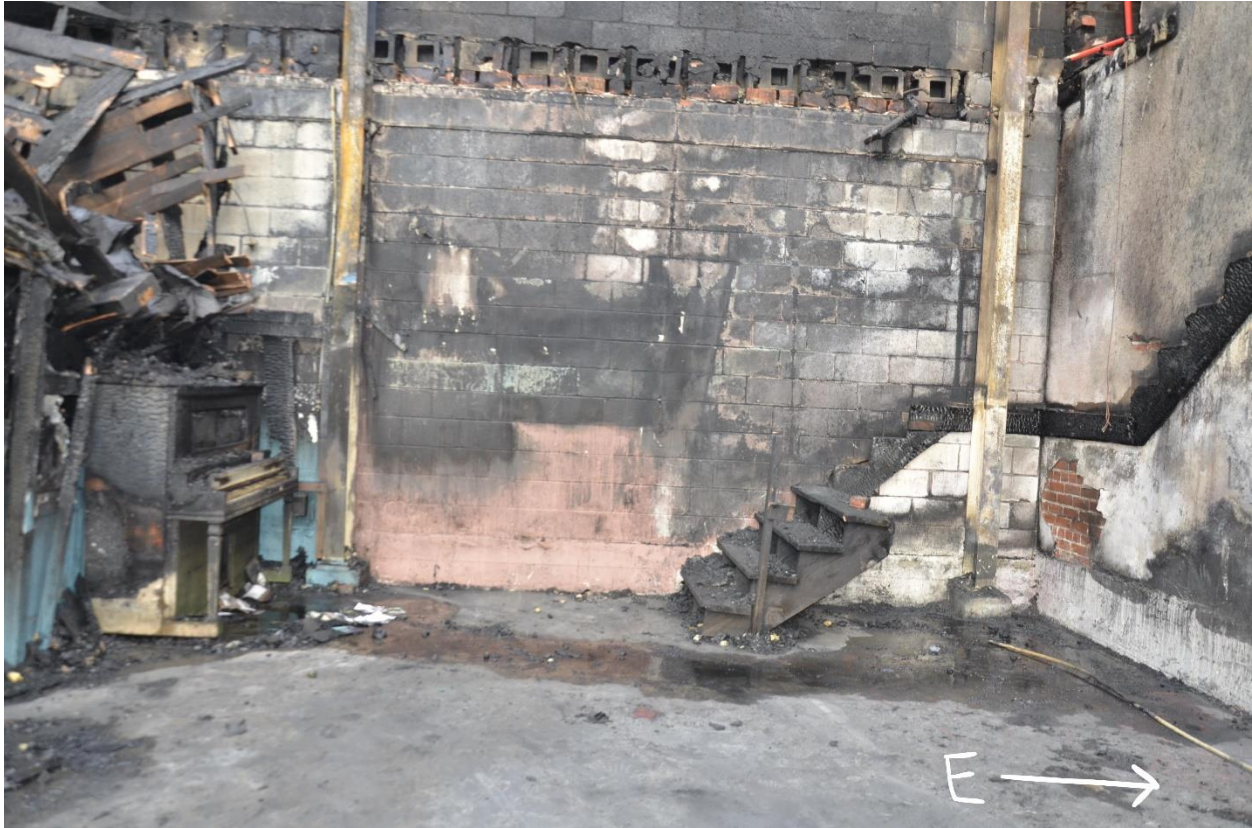
Investigators began to clear the area to the east of the platform making their way to the rear staircase. This area sustained extensive damage. The roof and second floor had collapsed into the area resulting in charring to wood members and furnishings. It was noted that during suppression efforts, this portion of the building was most difficult to access. Investigators cleared the area leading to the rear (north) steps finding the first four steps intact and in good condition. The remaining steps were consumed. (see photo next page)

Along the north wall, to the west of the steps, investigators examined a leather booth and a piano. The top leather of the booth sustained heat damage exposing the cushion material. The seat of the booth sustained some heat damage and was less damaged than the back and top of the booth. The rear of the piano rested against the travel trailer that was perpendicular to the north wall. The piano sustained heat damage with considerably heavier damage to the top than the bottom. (see photo next page)

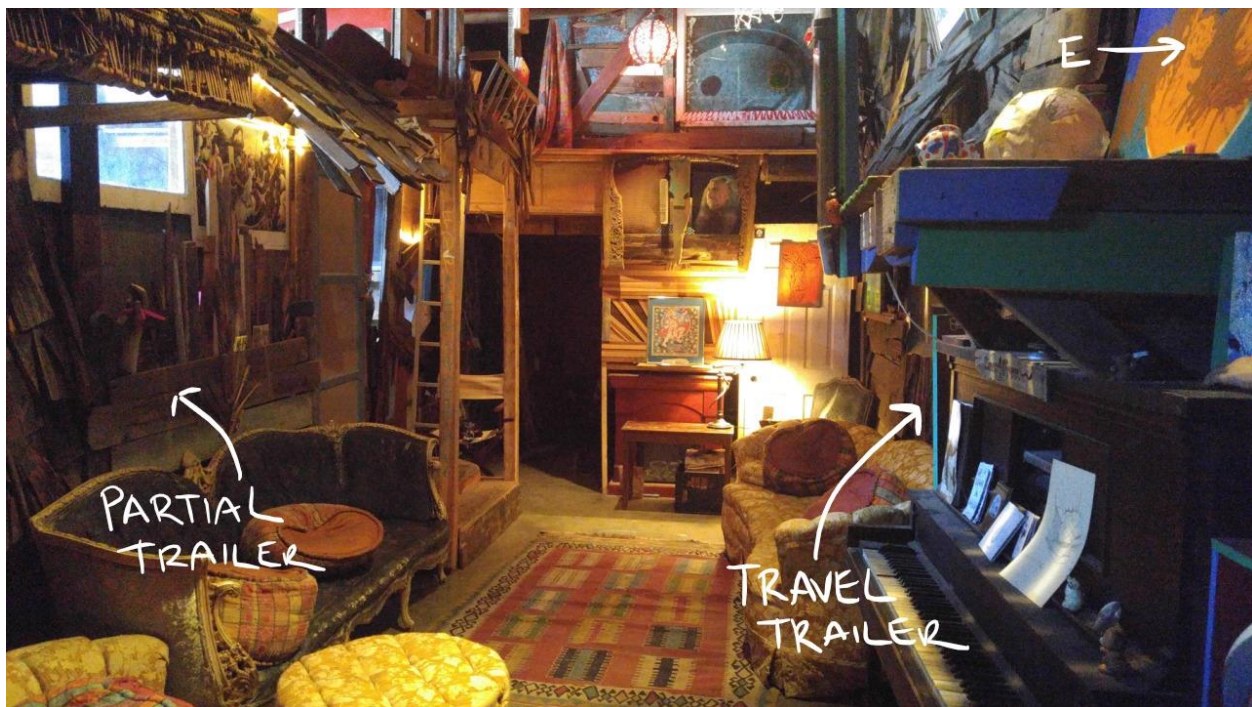
Next to this living space was a partial travel trailer, altered by previous tenants to customize the layout of the space. Reportedly, the south wall of the trailer was removed and replaced with a wooden wall that extended to the ceiling of the first story. The partial travel trailer sustained extensive fire damage. In addition, the roof and 2<sup>nd</sup> floor had collapsed onto it. Investigators identified and processed the space between the partial trailer on the west wall and the travel trailer against the north wall. Previous information from interviews indicated this was a lounge area. Witnesses had reported seeing flames in this area during the early stages of the fire. This space sustained extensive fire damage. Couches found in this area were more heavily damaged on their upper portions compared to lower portions. (see comparative photos below and next page)

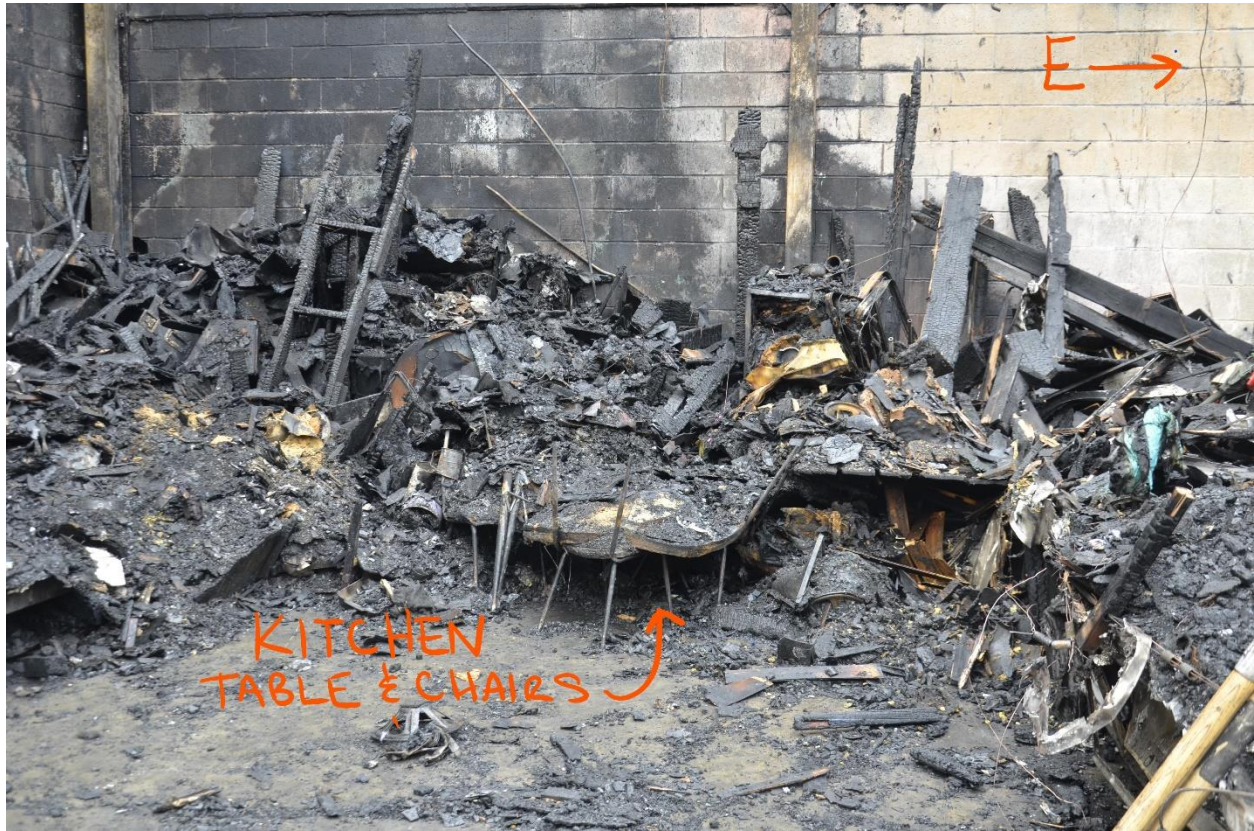
A makeshift wall that reportedly separated the lounge area from a living space located against the north wall of the building was consumed. A section of the door that accessed the living space was located in the debris. The door was heavily charred. (see photo below)

Directly inside the living space along the north wall, investigators removed debris, layer by layer, to uncover a kitchen table and chairs. The table had collapsed onto the metal chairs. The backrests for the chairs were consumed. Wood beneath the chairs' cushions was present but the majority of the cushion material was consumed. (see photo next page)

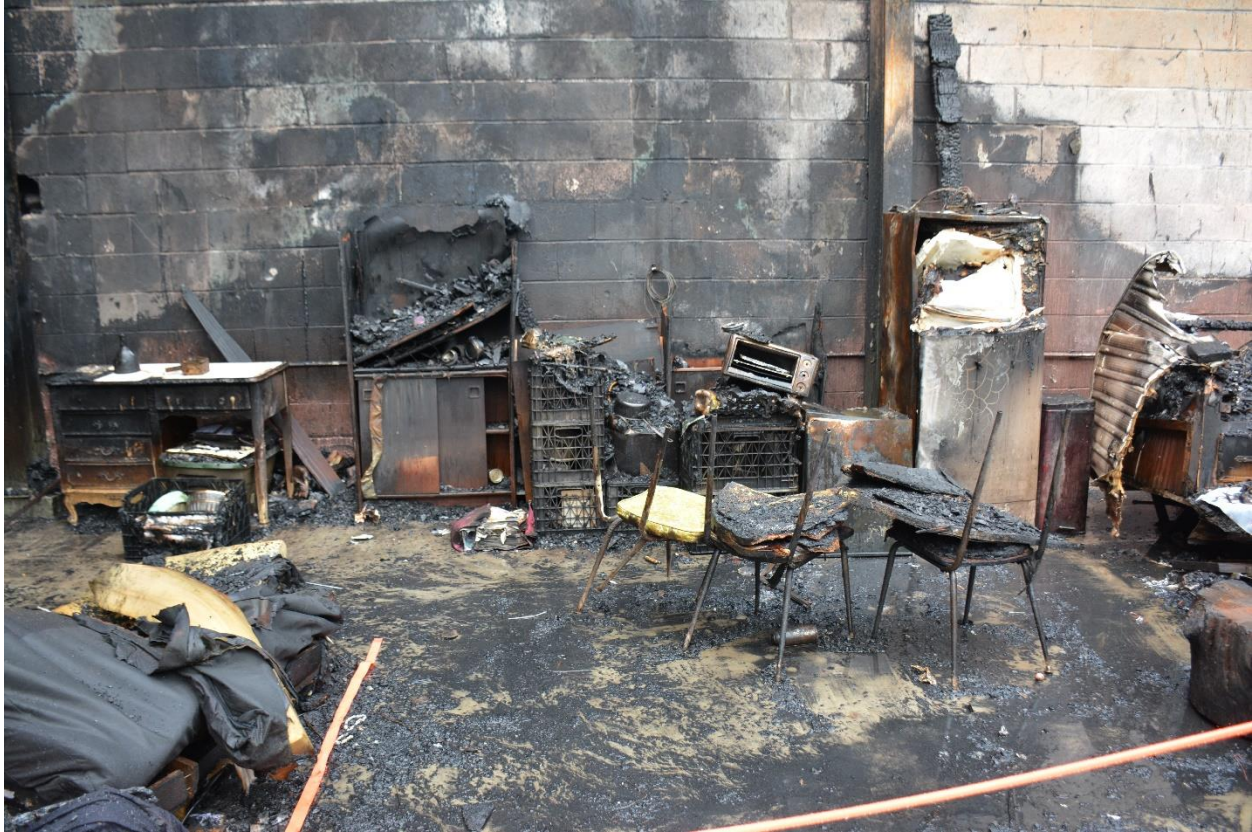
To the left of the refrigerators were several milk crates containing kitchen items. The milk crates were mostly intact. Behind the crates were two wooden storage cabinets placed against the north wall. The tops of the storage cabinets exhibited fire damage that diminished with proximity to the floor. (see photo next page)
