THE PLASCO BUILDING COLLAPSE IN TEHRAN

A Preliminary Assessment
FEBRUARY 20, 2017

**ARCHITECTS
& ENGINEERS**
for 9/11 TRUTH

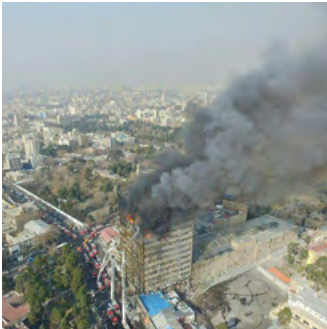
Figure 3: Aerial view of the building during the fire on January 19, 2017, showing the shopping mall at rear.

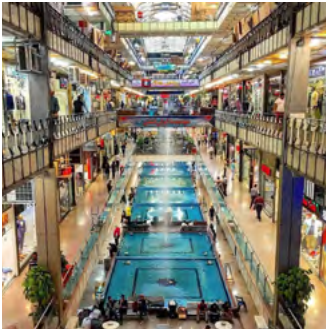
Figure 4: View of the four-story shopping mall from the entrance to it at the north side of the 15-story tower.

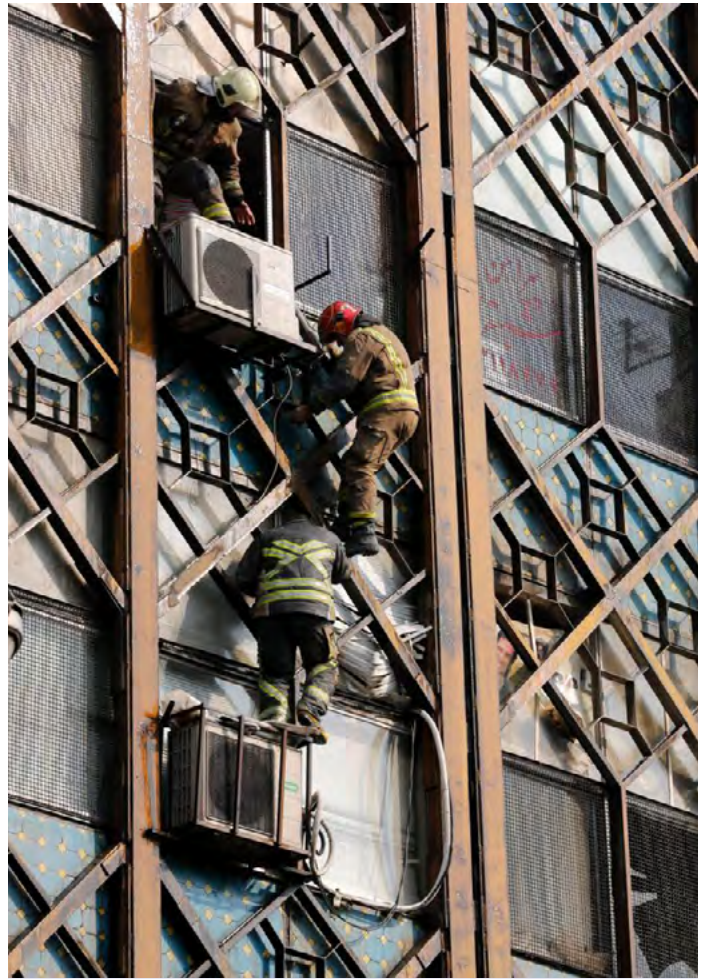
Figure 5: Firefighters are seen escaping through windows and climbing down the side of the building after a large explosion prompted the fire department to evacuate its personnel.

With regard to physical damage, the first large explosion, according to Mr. Maleki, "caused the massive destruction of the building's windows." Based on the fact that firefighters were attempting to escape through windows after the first large explosion, it may be that the first large explosion destroyed the stairwells and elevators as well. Alternatively, severe fires and smoke, perhaps caused by the explosion, may have prevented the firefighters from exiting through the stairwells.

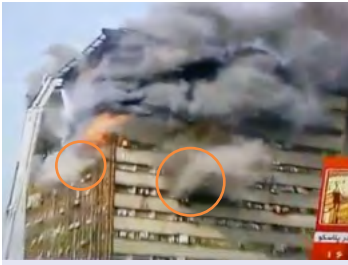
Figure 7: Video taken from the southeast.
https://youtu.be/XoyH_wYGpJ8

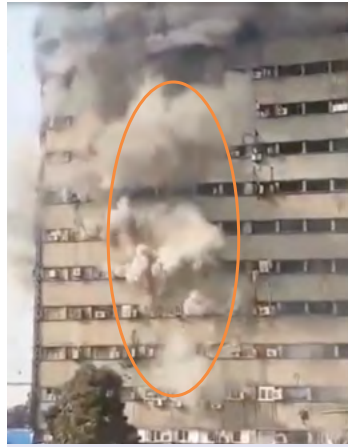
Figure 8: Video taken from the east.
https://youtu.be/_MgJTa7SDaY

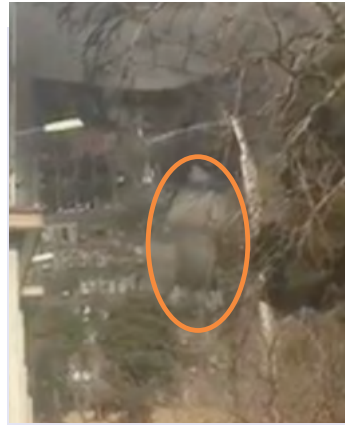
Figure 9: Video taken from the south.
https://youtu.be/_MgJTa7SDaY?t=58s

The occurrence of seven separate impulses is consistent with video of the south face taken directly from the south,¹² which does not show an explosion emanating from one point. Rather, it shows a number of explosions emanating along the same floor from the center of the south face to the east side of the south face.

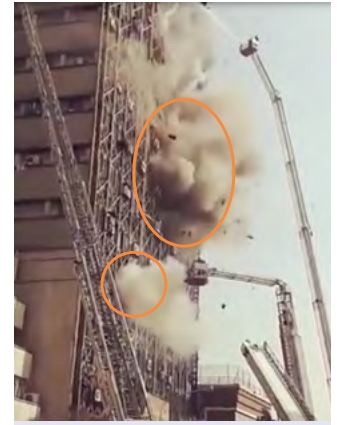
Figure 10: Video taken from the southwest closer to the building.
<https://youtu.be/jzB-QE8Emt0>

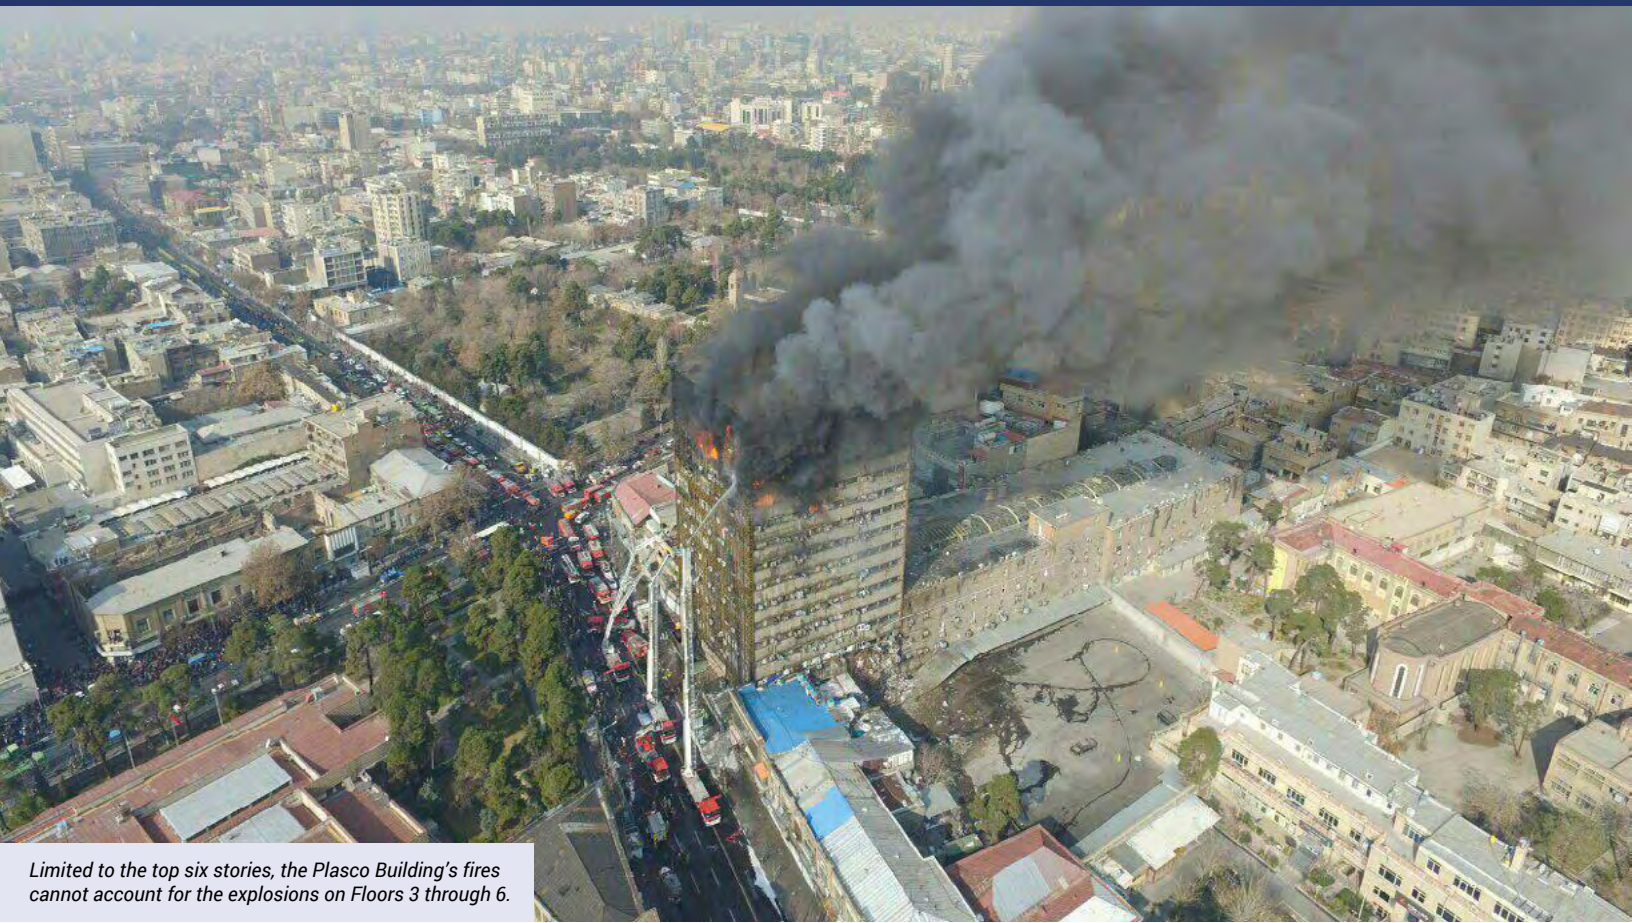
Limited to the top six stories, the Plasco Building's fires cannot account for the explosions on Floors 3 through 6.

Also, as we established in Section 2.1, fires could not have been the ignition source for the explosions that occurred before the collapse at the northeast corner on Floors 3 through 6, because the fires were limited to Floors 9 through 15. This fact alone appears to rule out the hypothesis that the explosions were caused by fire.
